# Energy Efficiency and Energy Management in Cultural Heritage

Case Studies Guidebook

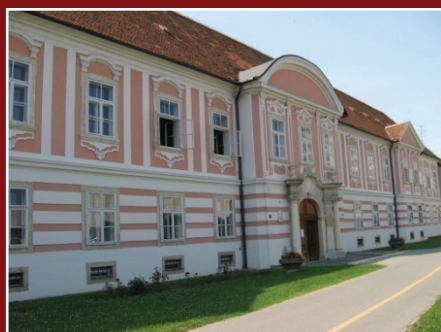
## MUSIC SCHOOL IN VARAŽDIN, CROATIA

Building: Music school  
Location: Varaždin, Croatia  
Purpose: School  
Built: mid 18<sup>th</sup> century

The Varaždin Music school (Croatia) built in mid 18<sup>th</sup> century; then completely rebuilt between 1999 and 2002 is a protected cultural heritage of Croatia. One of the energy efficiency measures identified by an energy audit was changing window glasses on the building. The auditors estimated that the adoption of this measure will result in a reduction of thermal energy consumption by 28%.

| Short description of current situation | External joinery on building is mostly wooden, wing to wing and originally made. All exterior joinery was replaced in 2001, and replacement is not required. Since the joinery is made of ordinary glass, it is recommended to be replaced with insulating glass. | | | |

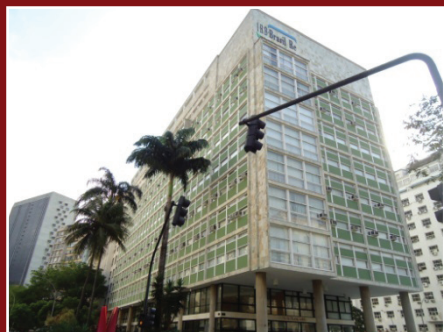
## THE BRAZILIAN REINSURANCE INSTITUTE BUILDING, BRAZIL

The original design of its facade structure is composed of prefabricated concrete enclosed by wooden frames and glass, and locks in asbestos-cement boards, which certainly contained asbestos in its composition. During the latest facade project developed and performed in 2010, the 4 mm window glasses were replaced with the 6 mm ones, damages in casings were repaired and external marble coatings restored. The project also specified internal white PVC blinds. An additional study to improve energy efficiency of the building and its environmental comfort proposes the following:

- Replacement of glass from common 4 mm to 8 mm;
- Glass wool panels in the empty spaces between the plates of locks;
- Replacement of asbestos-cement panels with panels without asbestos;
- Application of internal solar blinds.

To conclude, installation of window glasses with the optimum solar factor, inserting of glass wool between the plates and filling of the inner air chamber reduced thermal conductance and increased wall thermal capacity. This in turn reduced both the effects of thermal actions on the facade as well the internal thermal load and consequently the size and power consumption of the air conditioning system. (7)

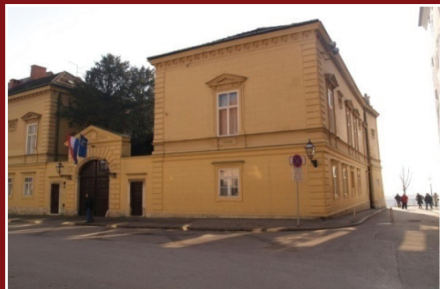
## CITY PALACE DVERCE, ZAGREB, CROATIA

Building: City palace Dverce  
Location: Zagreb, Croatia  
Purpose: public administration  
Built: 19th century

EE measure: Ceilings under unheated attic and external terraces (flat roofs) should be insulated with a 15 cm thick thermal insulation.

| Short description of current situation | Roof leaks in the old part of the building which will result in devastating damage on the construction of building. Ceiling under the roof is an arched vault made out of cane beams, plaster and rubble. Attic is classic, made out of beams, laths and roof tiles. Remediation is necessary because of the damage which could occur from the leaking roof. The current heat transfer coefficient U = 0.9 W/m <sup>2</sup> K. | | | |

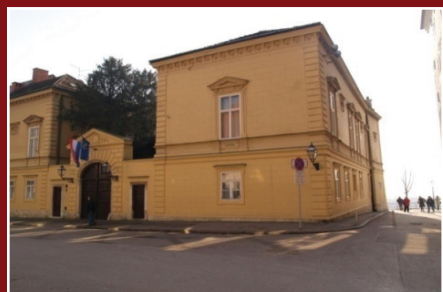
## CITY PALACA DVERCE, ZAGREB, CROATIA

Building: City palace Dverce  
Location: Zagreb, Croatia  
Purpose: Public administration  
Built: 19th century

EE measure: Thermal insulation of external walls should be carried out within dry walls in order to maintain the visual identity of the building. It is suggested to design a drywall system on 30% of the external walls surface and install a 10 cm thick thermal insulation.

| Short description of current situation | External walls are made of full brick approximately 60 cm thick. The building is not thermally insulated. Heat transfer coefficient is U = 1.01 W/m²K. | | | |
| Short description of measures/ materials/ technologies to be applied | Thermal insulation of external walls should be carried out within dry walls in order to maintain the visual identity of the building. It is suggested to design a drywall system on 30% of the external walls surface and install a 10 cm thick thermal insulation. | | | |

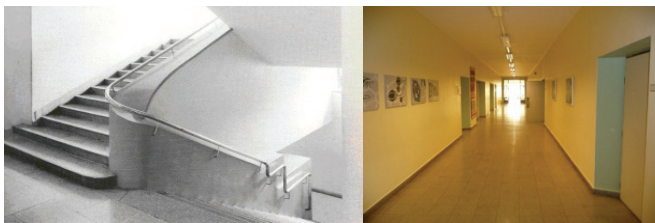
Figure 2.2. Main Stairway and corridor oriented to day light

The geometry of the classrooms (depth of 6.6 m) and the different tasks which must be performed in it makes it a difficult task to light it with daylight.

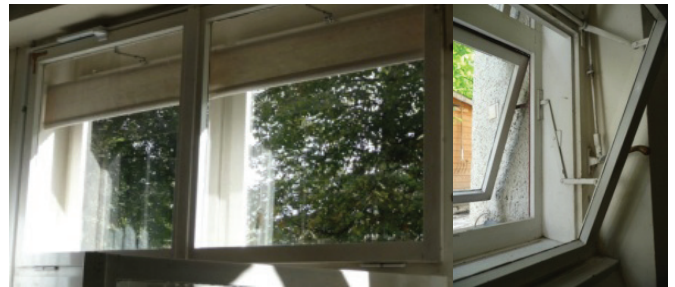
Figure 2.3. Photos and original drawings of the windows details (roller blind, tilt mechanism)

The box-type window gives the chance to integrate shading and daylight deflection elements in the space between the glazings. The advantage to external shading is wind protection as well as protection against staining.

The roller blinds installed at the moment have the disadvantage of low transmittance. There is no option for daylight redirection at the moment. The best way to avoid glare and overheating in summer is by use of overhang. However, as this is not included in the architectural design of the historic building, new ways to solve the problem have to be found.

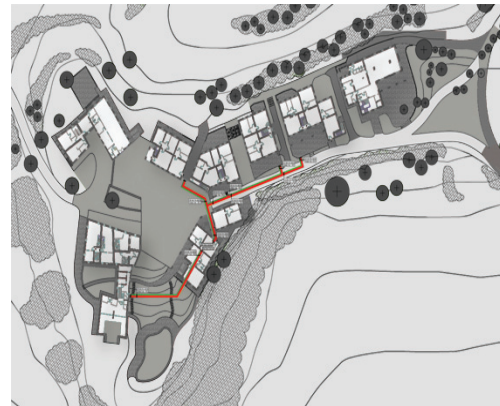
Figure 2.8. Layout of installations of Riverzana village

A centralised heating system was applied using condensation to distribute its energy to the final users through electro pumps. The installations for heat emission use a medium of low temperature and, according to the different areas, the radiators can be skirting board type or radiant panel type with reduced thermal inertia. (12)

The current project takes into account thermal engineering, the procurement of hot water, heating and air-conditioning facilities with the use of a central heat pump, located in a place of low visual impact. (12)

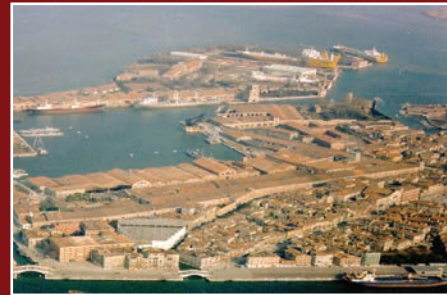
## VENICE ARSENAL

The Venice Arsenal is located on the eastern edge of Venice's historic centre and it covers an area of approximately 47 hectares. Open (unbuilt) area accounts for 218,000 m<sup>2</sup>, while buildings cover a total surface of 150,000 m<sup>2</sup>. The northern part of the Arsenal was constructed during expansion projects that began in the late fifteenth century and ended in the early decades of the 1900s. The newly designed heating and cooling system is based on water to water heat pump system with Venice lagoon sea water as an energy source.

High efficient HVAC systems are based on water heat pumps, geo exchange in lagoon that produces fluids for conditioning. In this case, low enthalpy district heating (closed loop) will connect all the buildings in the north Arsenal, transferring the geothermal energy to the heat pumps from the Venice Lagoon by means of a centralized heat exchange plant. The system operates on the principle of thermal exchange: the lagoon water is used to dissipate heat in the summer and provides a source of heat in the winter (in other words, a geothermal plant that uses lagoon water).

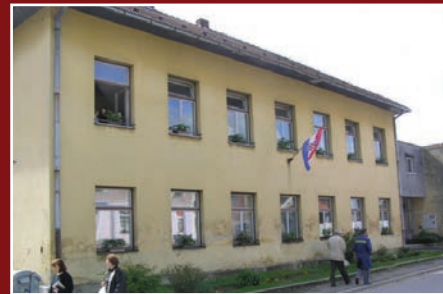
## ELEMENTARY SCHOOL ANTUN MIHANOVIĆ, KLANJEC, CROATIA

The oldest school building was built in 1888 with typical construction technique for that period. Due to bad shape of building construction and inadequate temperature regulation in classrooms energy efficiency measures that are implemented include increasing thermal comfort within the building and reduction of energy consumption for heating by automatic regulation of room air temperature and replacement of windows.

The oldest school building was built in 1888 with typical construction technique for that period. The rest of the building was erected in 1960. From construction perspective the building as a whole is in bad shape. Plaster on building walls is damaged and at some places it is missing or detached. Damages caused by rain water on building envelope are clearly visible. Wooden window frames are damaged and in bad shape as well. Regardless of energy efficiency measures implementation, windows have to be changed due to their bad condition.

Wooden windows are completely worn-out, with destroyed seals, damaged shackles and peeled off protective primer colour. Particular parts of window frames are rotten and severely damaged so they present potential threat to users.

Single glazing metal doors and windows are made with metal profiles without broken thermal bridges, without seals.

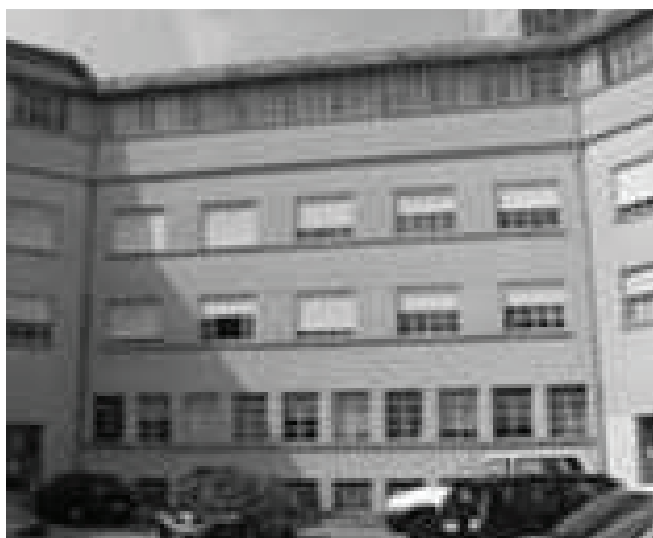
Figure 2.10. General view of the building (west, north and east wing)

The walls are concrete masonry units 27 cm thick with plaster finishing and the roof is a concrete slab. All the windows are single glazed with metallic frames. The ground floor windows do not have any shading devices and the first floor windows have venetian blinds placed inside. The windows on the second and third floors have roller shutters while the windows on the fourth floor have curtains. The building is naturally ventilated and has a central heating system with an oil boiler hot water distribution system and radiators in the offices and meeting rooms. There is no centralized cooling system and most offices do not have any active cooling systems.

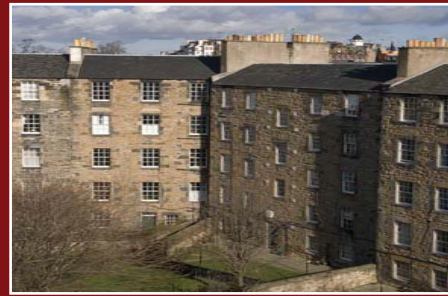
Traditional Scottish tenement flat, built from stone in the 1800s and grade 'B' listed due to its quality and its location in central Edinburgh. Solar systems were provided to householders on all floors of the tenement buildings (even those at basement level), with the panels being hidden in roof valleys to satisfy conservation requirements.

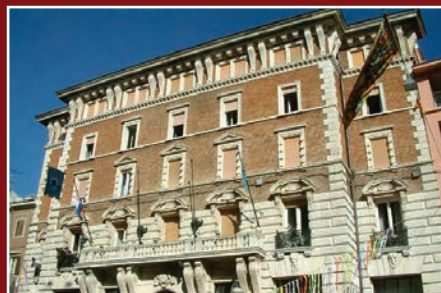
The Rijeka Municipality building was originally built in 1914. In 2009 photovoltaic power plant of 9.9 kWp was installed and put in service on the upper terrace of the building. That was technically and financially acceptable for the owner of the building, as well as for the investor. The City of Rijeka also accepted the Sustainable energy action plan (SEAP) and started with the implementation of smart metering in that same building.

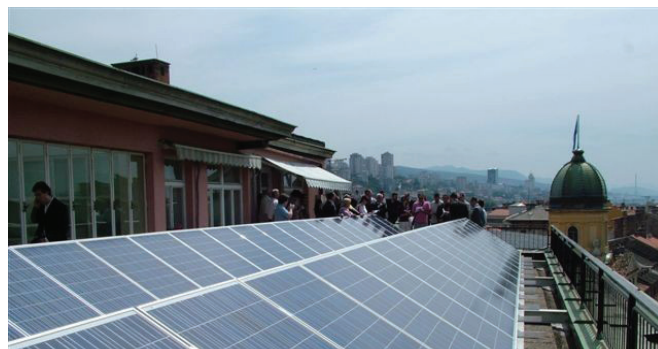
Figure 2.13. PV system on the Rijeka Municipality building

The first solar power plant was built in June 2009 on the Municipality building, in the centre of Rijeka. Total installation power is 9.9 kW and yearly predicted electricity production is around 12,000 kWh. Nowadays, the total electricity production is used for the building's electricity needs while the process of feed-in tariff registration is still ongoing.

Further research of PV investment feasibility demonstrates positive net present value and solid 9.17 percent of IRR. Calculations were made with the feed-in tariff selling price of 0.51 EUR per kWh electricity production and sale to the grid, for the next 12 years, according to Croatian regulations. (20)

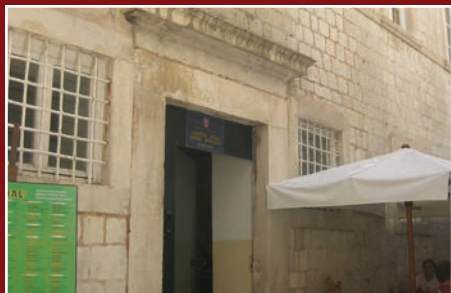
Elementary school Marin Getaldić was built in masonry limestone at the end of the 16th century while first adaptations started in late 1817. Last renovation was done in 1986 when the roof was completely reconstructed. The school is located in the strict centre of the City of Dubrovnik and is therefore under protection as a cultural heritage building. Electricity is the only energy source present in the building. Instead of using pure electrical resistance heating, the utilization of air to water heat pump would cut electricity consumption for heating by factor 4. Moreover, installation of PV modules, with the total collector area of 36 m<sup>2</sup>, would enable production of 5,133 kWh of electric energy annually with the total income of EUR 2,600 per year.

Total useful area of the main building is 1,030 m<sup>2</sup>, and 250 m<sup>2</sup> of gym. Main building walls are built with 50 to 85 cm thick limestone blocks with 3 to 5 cm of lime-cement plaster on the inside. Floors and roof are wooden without thermal insulation applied. Double wing windows are of wooden frames with single 3 mm white glazing. Although construction elements of building envelope (walls, windows, roof, floors) are visually in good shape they do not satisfy conditions under Croatian Technical Regulation on Energy Economy and Heat Retention in Buildings (NN 110/09, 89/09) as shown in Table 2.16.

With respect to the available space for installation of PV modules it is recommended to install a  $5 \text{ kW}$  solar power plant. Number of PV modules to be installed is 28 (configuration of 2 threads with  $2 \times 7$  modules) with the total collector area of  $36 \text{ m}^2$ . With this system it is possible to produce  $5,133 \text{ kWh}$  of electric energy annually with a total income of EUR 2,600 per year. With investment cost of EUR 19,000 payback period is expected to be 8 years. (21)

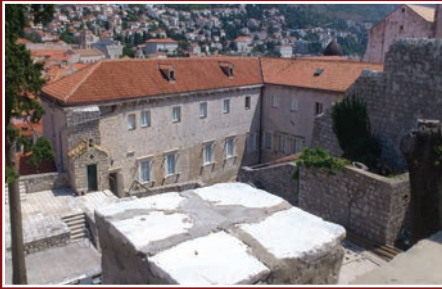
Luka Sorkočević Art School in Dubrovnik aims to substitute central electrical heating with other energy efficient solutions. The building with an area of 1,730 m<sup>2</sup> is located in the strict city centre and is under protection as a cultural heritage.

According to a preliminary energy audit, among various different options for retrofitting of the heating system and simultaneous introduction of a cooling system the most energy efficient and economically viable solution is to install air source heat pumps.

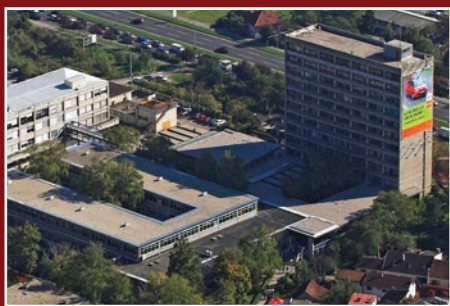
Refurbishment of the FMENA south building complex consists of:

- building envelope reconstruction – application of thermal insulation on concrete elements and replacement of windows,
- heating system replacement – reallocation and reconstruction of central heating room, replacement of heating distribution system (pipelines and radiators), introduction of regulation system
- introduction of passive ground water cooling system
- reconstruction of lighting system – replacement of old lamp units and wiring and implementation of lighting regulation system
- installation of 30 kW photo voltaic power plant
- introduction of central monitoring and regulation system.

The existing building walls are solid concrete blocks without elements of thermal insulation. Windows are double pane wooden frames with venetian blinds between white glazings. Windows are generally in bad shape; wooden frames are distorted, rubber seals are missing, metal shackles are damaged and protective primer is partially colour peeled off. Venetian blind mechanism works only in few particular cases.

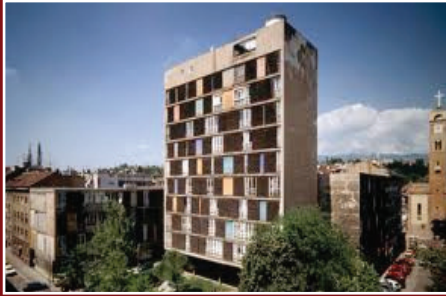
The building has undergone an energy audit for the purposes of establishing possibilities for energy efficiency improvements. It is a protected cultural monument planned for restoration due to deterioration. The Laganjina 9 ("Vitić's skyscraper") residential building is located in Zagreb city centre. It was built during the period between 1957 and 1960 based on architect Ivan Vitić's design.

Total useful heated area of the building is 3,753.72 m<sup>2</sup>. According to the calculated energy consumption for heating the building is rated **energy class E** with the reference value of necessary thermal energy of **182.13 kWh/m<sup>2</sup>a** which is significantly more than maximum allowed value of 58.63 kWh/m<sup>2</sup>a. **Electric energy and natural gas** are used for energy requirements of the building.

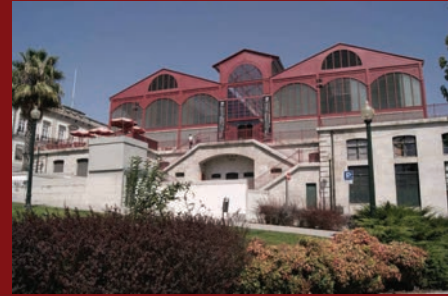
The Mercado (market) Ferreira Borges was built in 1885 and is a relevant example of the iron architecture in Porto.

The design solution was tailored to the intended use for the building, namely the installation of a live music performance hall, the Hard Club. Accordingly, two large containers were installed inside the building with no connection with its envelope thereby housing two fully insulated concert rooms.

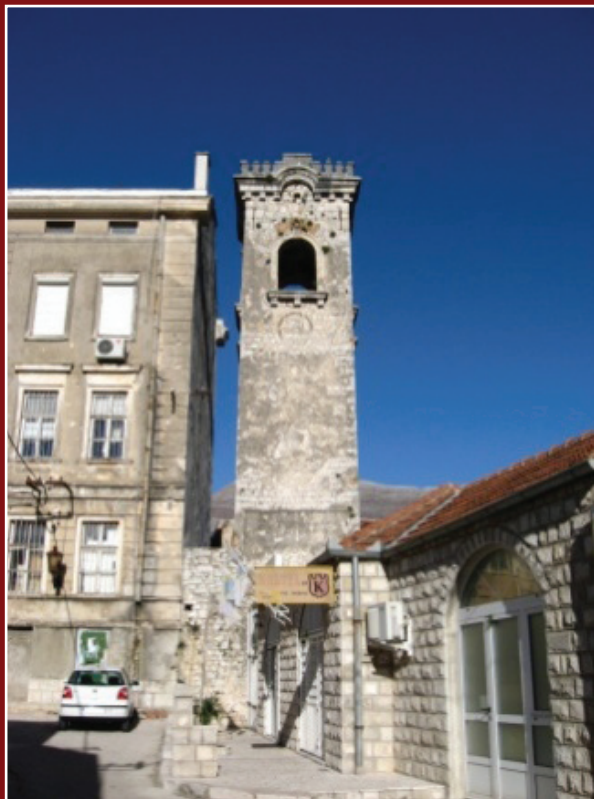
The Museum of Herzegovina is located in the Old Town of Trebinje, which is a listed cultural and historical complex. It is a three-storey stone building (ground level + two storeys) and it was constructed at the very beginning of the 20th century. The Museum complex comprises a few more stone structures - a building for storing bequests, an accessory building housing the museum depot, a clock tower, and a building used as a station or dove cote for carrier pigeons, one of a kind in this region. Energy needed for heating and cooling is 250 kWh/m<sup>2</sup>a.

Exterior walls are impossible to insulate on the outside. Therefore, the plan proposes to install thermal insulation on the inside. Given the fact that the plaster is already in a fairly bad condition, it is planned to remove the current interior layer of plaster, install mineral wool as thermal insulation, including a vapour control layer, and cover the walls with plasterboards. Also, it is necessary to rewire the building and install ventilation ducts. The minimum 10-cm thermal insulation planned for installation will help secure the required heat transfer coefficient  $U = 0.273 \text{ W/m}^2\text{K}$ , while 15 cm of thermal insulation would help have as much as  $U = 0.197 \text{ W/m}^2\text{K}$ . Since the attic will be used as exhibition space, it needs to be insulated additionally. A total layer of 22 cm of thermal insulation needs to be installed between and under the rafters, which would ensure the heat transfer coefficient of  $U = 0.154 \text{ W/m}^2\text{K}$ . As the ground level floor is not insulated, it is planned to lay additional

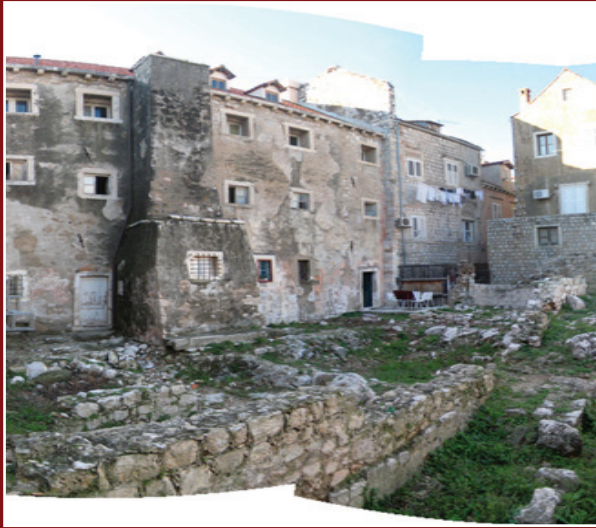
An 18<sup>th</sup> century building located in the Karmen neighborhood. Originally built as a hospice, and remodeled in the 19<sup>th</sup> century as a prison, the building has not been in use since the early 1980s. Three decades of neglect have left this heritage property in a state of decay, and the city's allocation of the building for a public program, makes it an exemplary candidate for renovation. In addition, the building is located next to an archeological site Pustjerna, which has been designated for a new, mix-use construction. The heritage property chosen is a 3 story (ground floor, first floor, second floor, attic) building with an attached garden and an underground water cistern. Similar to other historic stone buildings in Dubrovnik, both the interior and exterior walls of the former prison are 50cm - 80cm thick, consisting of massive stone layers coated in stucco on the outside, and an intermediate fill layer consisting of smaller rough pieces of stone and cement. The ceilings are wooden, and the roof consists of a wooden frame covered in clay tiles.

Strategies for better energy performance were tested in energy modeling software. The calculated energy demand for the baseline model is **94.8 kWh/m<sup>2</sup>**, which is relatively high compared to contemporary standards. After simulating the baseline model, four sets of strategies were separately tested: thermal insulation, glazing, HVAC and lighting. The results suggest that incorporation of this set of improvements will decrease electrical demand by **40%**.

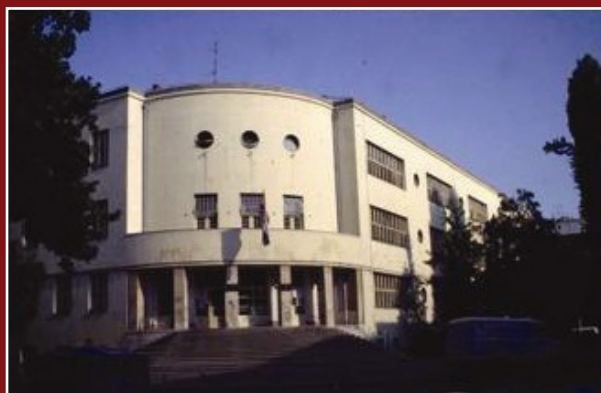
**92.5%** higher than the quotas set for specific transmission thermal losses. Annual thermal heat demand needed for heating is **92%** higher than the quotas set for annual heat demand needed for heating (Table 2.28).

This project suggested thermal improvements to the building envelope divided into three steps: 1. improving thermal performance of basements, floors and roofs, 2. Improving walls insulation and 3. Improving window insulation. The heat requirement can be reduced by insulating the unheated attic ceiling (by adding the insulation layer i.e. expanded polystyrene EPS or mineral wool MW: 12 cm). If the basement is used, the thermal performance of floors (EPS: 10 cm) and walls (XPS: 10 cm), contribute reducing heat loss. In order to attain a satisfactory heat loss limitation level thermal insulation should be applied in the unheated basement ceiling (MW: 12 cm) as well as in the roof construction (by adding the insulation layer in flat roofs - EPS: 12 cm and in pitched roofs (MW: 10 cm). Thermal insulation of walls is integrated inside with the mineral wool (MW: 8 cm) with vapour barrier in order to prevent condensation. Wooden double windows (single-glazed) and outer sun protection (shutters) should be kept and repaired. This project suggests specific windows advanced with double glazed low E (3+8+3 mm) secondary glazing (**U-value = 1.1 W/m²K**) but will need a planning permission from the Municipal Institute for Protection of Cultural and Natural Monuments. If all three measures are implemented in the building the annual thermal heat demand will be reduced from **38.5** to **16.41 kWh/m³a**. (29)

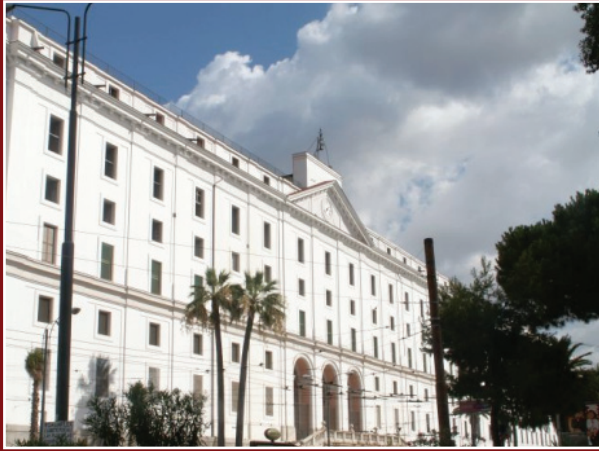
The Real Albergo dei Poveri is one of the hugest XVIII century hospices in Europe and it is being restored as an "Eco-building". The worksite for the construction of the Real Albergo dei Poveri, in Naples (Italy) started in 1752, under design by architect Ferdinando Fuga.

A transition from the concept of "monument" to the concept of "cultural heritage" leads to a methodology of investigation, design and work which binds the observation and study of environmental characters determined by monuments and their context. The project team aimed at applying an integrated design for an eco-building - innovation in planning and architecture to reach sustainability, at adopting natural and local components and materials, as well as integrating renewable energy systems in the restoration of the ancient building. Considered a *demonstration site*, the project includes integrated project planning, active and passive solar design, low energy construction, including sustainable materials and components as well as renewable energy technology and building energy management systems. Thermal mass has been taken into account, because the building is a massive structure made of brick and volcanic tuff and its walls have very good thermal insulation properties. This is used in the restoration project within the energy strategy.

A large underground storage was created for storing and reusing of rainwater collected by the building, in order to reduce the building's water needs. This will be used for toilet flushing and for watering of plants in the gardens. The upper floors were designed to take maximum advantage of the natural light (passive solar design) in order to reduce the energy demand for lighting. Another benefit of a passive solar design is good control of overheating in summer. To be in accordance with the original building pattern, custom designed semitransparent PV modules will be installed to produce around **88,125 kWh/a** of electricity. Photovoltaic has been chosen for its multi-functionality as it is a roof material that can allow natural lightning and generates energy. (30)

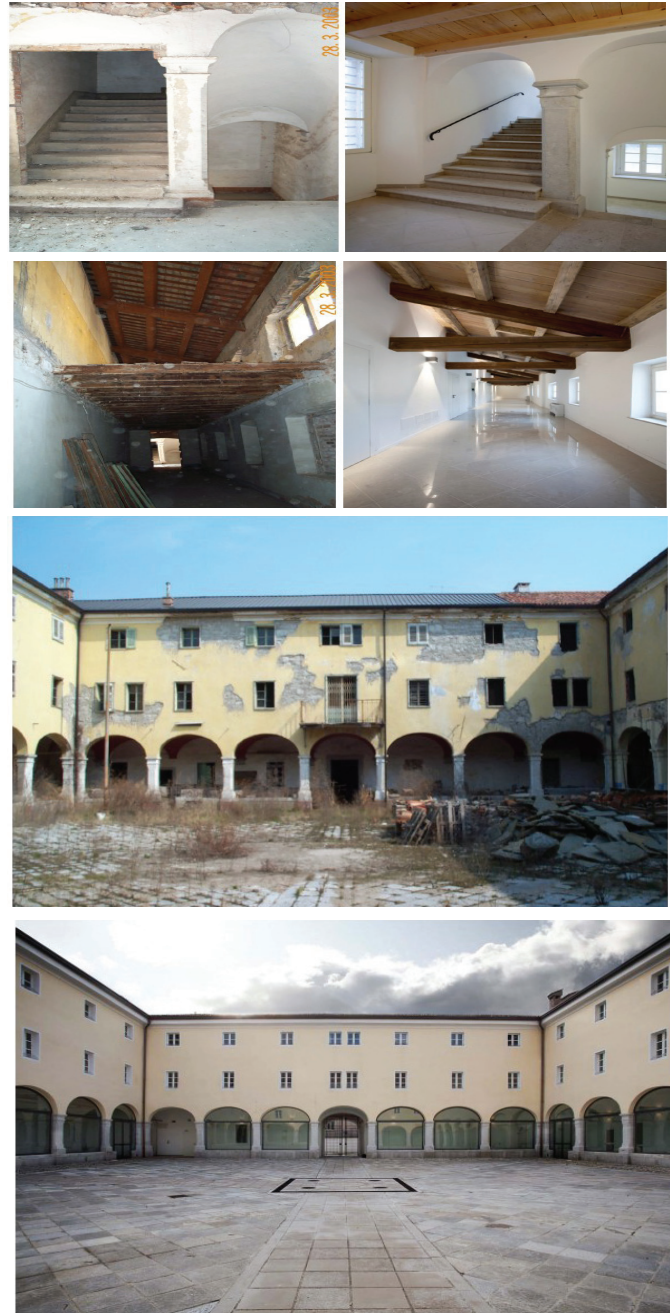
Figure 2.26. Claire's former Convent in Gorizia, Italy

The profiled polystyrene insulation panel is 10 cm thick in the lower part and 14 cm thick in the upper part of the fret surmounted by the above mentioned OSB panel. The panels are fitted with side battens that overlap according to the direction of the roof pitch to avoid thermal bridges, seals and joints. The shaping of the panels allows the formation of 4 cm deep ventilation channels.

The panel was waterproofed in the production phase using a 3 mm thick bituminous polyester sheath self-protected with slate chippings. (31)

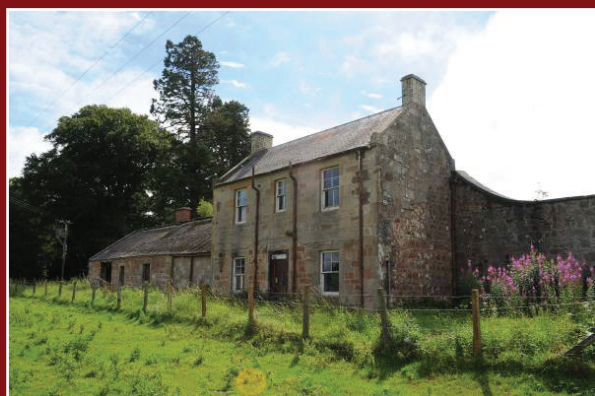
The Garden Bothy is an unoccupied 19th-century stone building in Ayrshire, South-West Scotland. It is a two storey cottage with two rooms on the ground floor and three rooms (including a small bathroom) on the upper floor.

Windows of the cottage are timber-framed, single-glazed and they will be removed, re-glazed, fitted with draught strips and re-fitted. With windows and door improvements a calculated improvement of **5%** in the energy running costs, equating to **0.8 tons of CO<sub>2</sub> per annum** is achieved with this intervention.

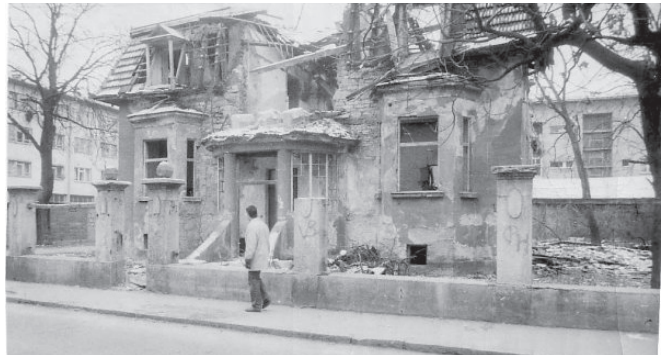
Figure 2.28. A photograph of Villa Božić in the 1980's, showing traces of time and neglect that gradually led to its demolition

Vila Božić in Banja Luka was built in 1912. by the prominent Croatian architect Rudolf Lubynski. It was heavily damaged by an earthquake in 1969. and completely demolished in 2002. The heat loss of the original house, according to the design of the house as described in the above-mentioned blueprints, equaled 48,940 W, or approximately 111.2 W/m<sup>2</sup> of the heated area. The annual energy consumption used for heating was estimated at approx. 123.5 kWh/m<sup>2</sup>. According to the new preliminary design, the envelope, ceilings and floors will be insulated, and windows with improved energy performance will be installed. This will help reduce the heat loss, which will amount to approx. 19,880 W, or around 45.2 W/m<sup>2</sup> of the heated area, on the condition the house is continuously heated. The calculation results show that by using multi-layer insulated walls and changing the mode of

operation of the central heating system the heat loss of the building may be reduced by about 29,000 W. In addition, the capacity of the heat source to be exploited for its heating can be almost 60% lower than what will be needed if the proposed measures are not implemented. The proposal to reconstruct the entire villa in its original form takes into account its historical value, the possibility to change its use and use modern materials to reduce its energy consumption. The results obtained taking into account the proposed energy efficiency measures are compared with those obtained without their application. (34)

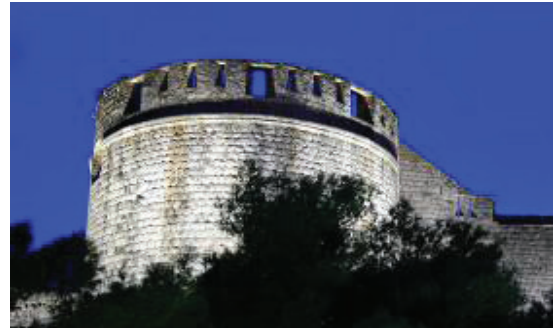
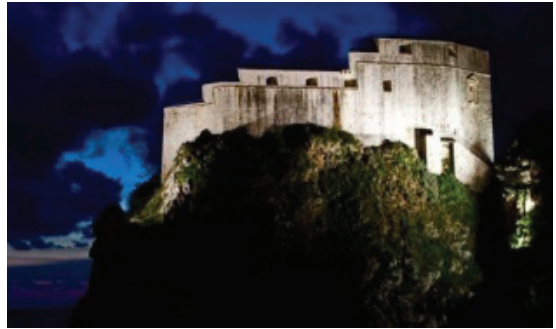
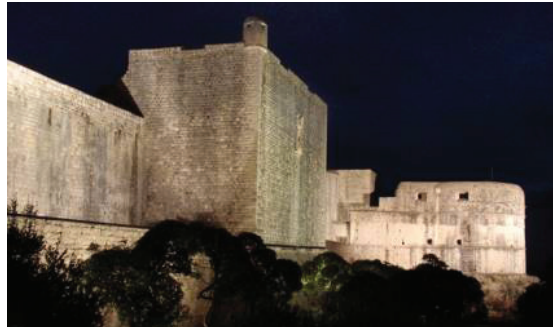
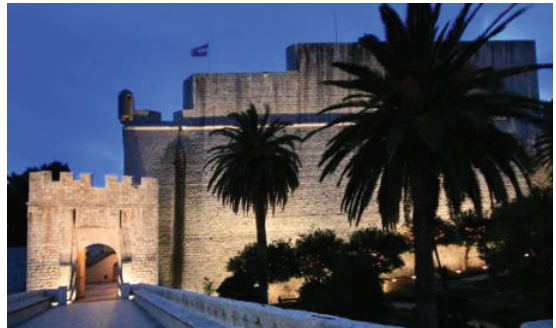
*Figure 3.3. Realization of lighting of Dubrovnik City walls*

Reconstruction of public lighting in Dubrovnik was carried out in three phases. The first phase included illuminating of the external line of city walls so that the entire city could be visible from the open sea. The first phase of the lighting project of the city walls (apart from the external line) as well as squares, streets and parking areas around the whole

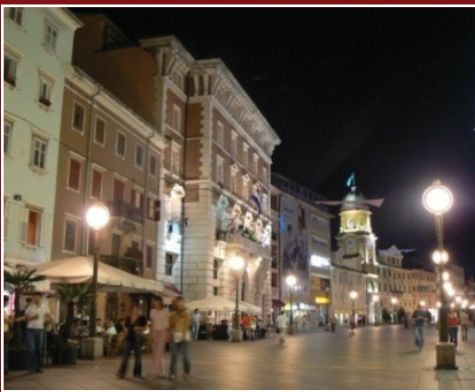
Illumination of Korzo after the reconstruction and transition to "white light"

**Illumination of the urban centre of Rijeka** has been done with decorative lightning custom made for that purpose. Lighting installed on the main pedestrian zone in the City of Rijeka - Korzo, includes decorative bronze poles and Philips lighting equipment installed inside decorative light fittings. Classic high pressure sodium lamps which have been used in the light fittings until 2007 had the colour temperature of 2,000 K and colour rendering index of 20. In 2007 Philips MasterCity White lamps with the colour temperature of 2,800 K and CRI of 83 replaced the existing installation of yellow sodium lights. The dimensions and the caps of the new lamps matched the old ones which made the transition much easier. The technology used in the new lamps is A ceramic halide technology, so far mainly used in shopping malls, is applied in the new lamps.

The difference in colour temperature and in increased colour rendering index can be seen on the above photos of Korzo and its illumination before and after reconstruction. The installed light-fittings are not shaded and have a spherical form, placed along both sides of the pedestrian zone. This ensures high quality illumination of the pedestrian zone as well as the historical buildings and their facades. (41)

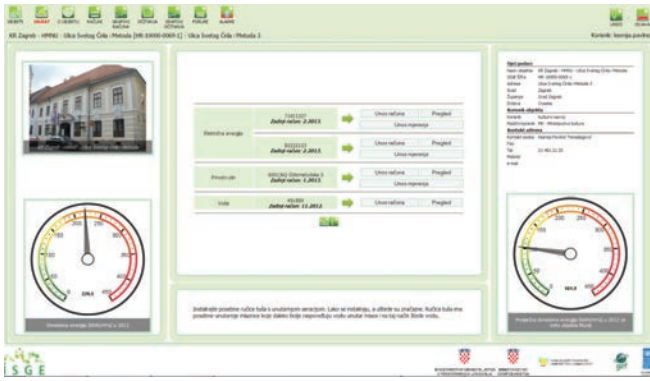
Figure 5.1. User interface

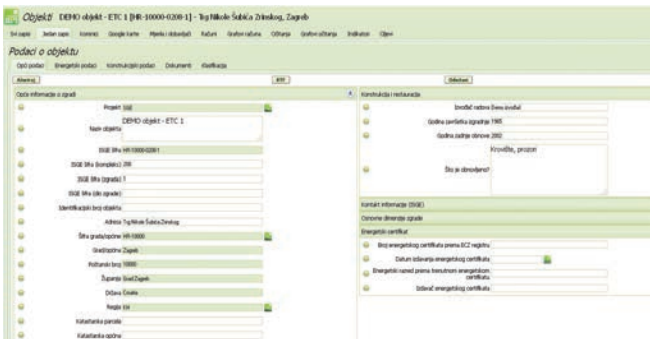
Figure 5.2. Data entry

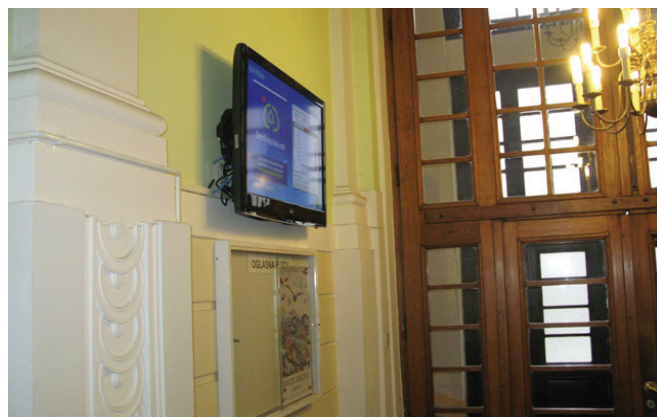
Figure 5.6. EE display panel

Apart from the real time data, the display panel can show practical advice on energy savings which employees can utilize at home or at workplace. Positioning of the panel on a location with high visibility raises awareness about energy consumption in offices and emphasises the importance of energy efficiency and energy management.

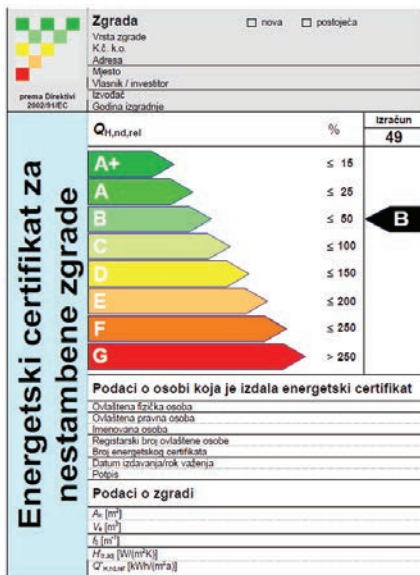
Figure 5.7. Example of energy certificate for non-residential buildings, Croatia

Energy certification shows an overall state of a building's energy systems as well as specific annual consumption of energy. This is a good indicator which can be used for comparison of energy performance to buildings of similar type. Cultural heritage buildings are excluded from EPBD directive and are not forced to issue energy certificates, however energy audits and energy certificates can provide an important step towards implementation of energy efficiency measures. (50)

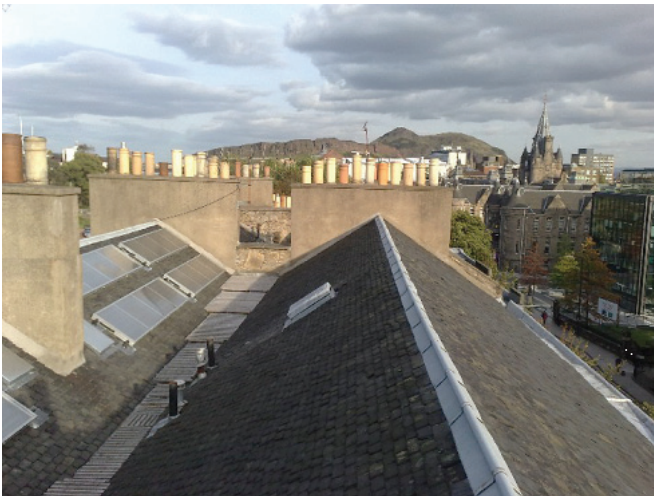
### EXAMPLE 1

Solar collectors that provide hot water for all the building tenants were installed in 49 residential buildings within the UNESCO-protected city of Edinburgh.

The collectors were placed between roofs shaped in the form of the letter “M” and as such were not visible from the road, thus satisfying the conservationists’ requirements. This solution deemed plausible to be replicated in Scotland and beyond.

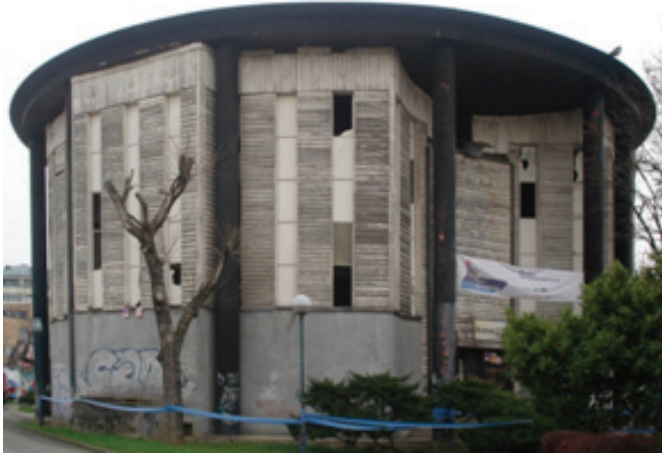
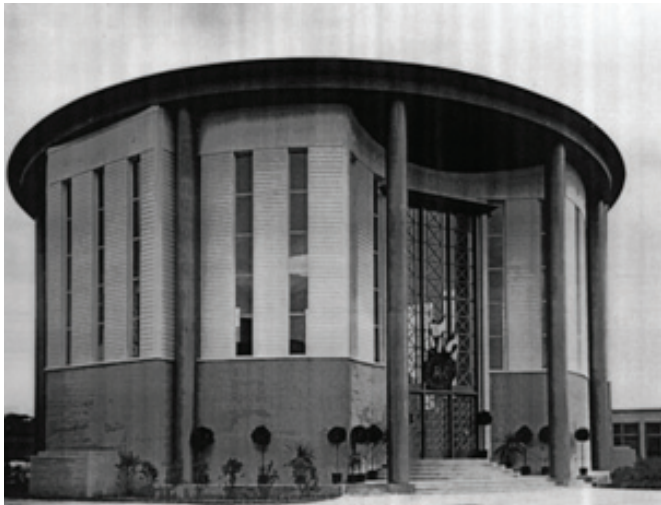
### EXAMPLE 3

The project encompassing the renovation of the French Pavilion in Zagreb was also presented. The project was based on the principles of conservation of cultural heritage and energy efficiency, thus accomplishing a reduction in the annual energy use for heating by more than 320,000 kWh.

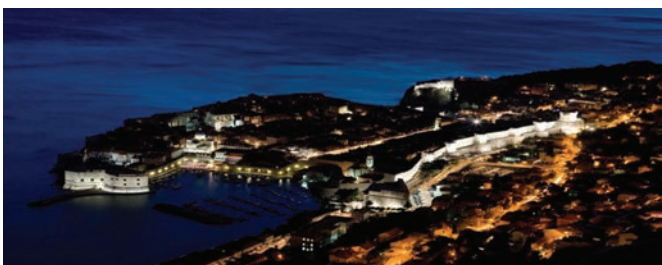
### EXAMPLE 4

Besides examples of specific building renovations, various examples of significant energy savings in protected urban cores were also presented. After completing the reconstruction of public lighting in Dubrovnik, the city's annual costs for lighting will be reduced by more than 400,000 EUR.
